REPORT OF MARINE SURVEY

“G-FORCE”

2006 64’ CAISON YACHTS

June 28, 2018

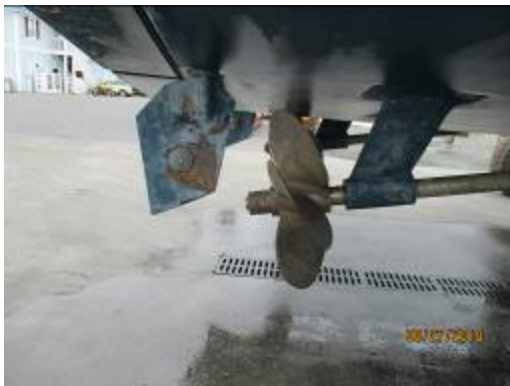
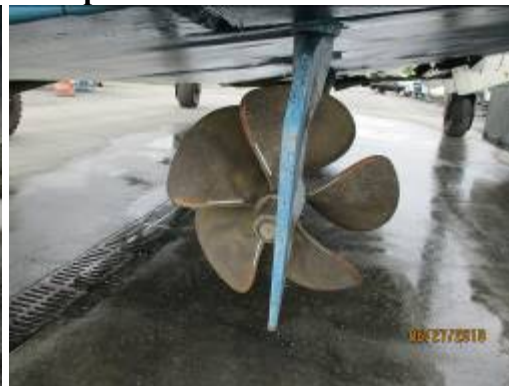
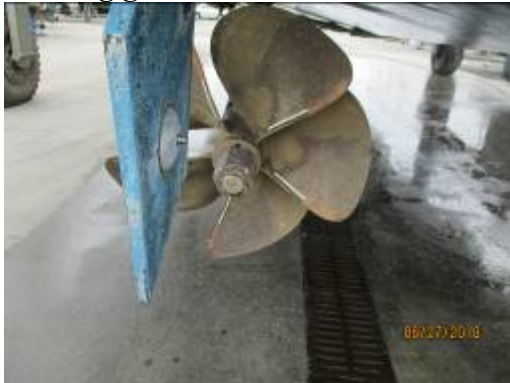
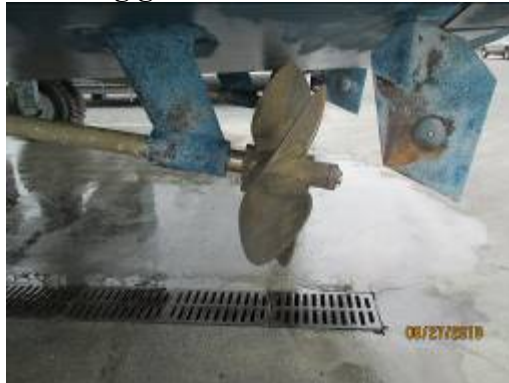
**running gear**

Wetted Surface/Keel: A visual inspection and hull sounding were performed. All findings were satisfactory. The vessel's running gear was also inspected. The shafts are 3 1/2" diameter stainless steel. The props were 5 blade Veem Interceptor variable pitch types (reportedly 32 1/2" diameter). The strut bearings were serviceable, reported to have been replaced/installed in 2017, Orcott brand.

NOTE: The props were not removed at the time of survey, thus the shaft key ways could not be inspected for cracks. The distance from the hub of the props to the struts were within ABYC recommended tolerances (2 and 5/8" on port and 2 3/4" on stbd side). The prop nuts were arranged opposite of ABYC recommendations. The bottom paint was built up/flaking off in some areas.

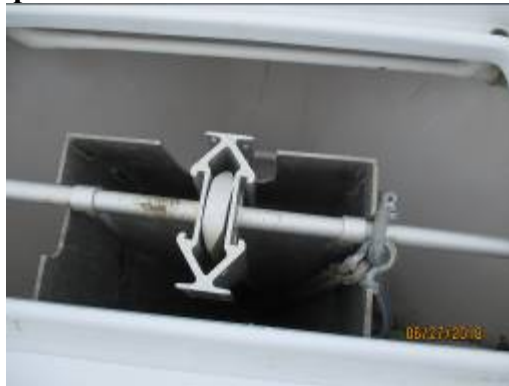
**anchor locker**

Anchors: Danforth type found to be in good condition.

Rode: There is chain and 3 strand nylon for rode. Exact lengths unable to be observed. The bitter end was not observed.

It is recommended that the primary and a spare anchor be made ready for offshore use, and that the rode be inspected with bitter end secured.

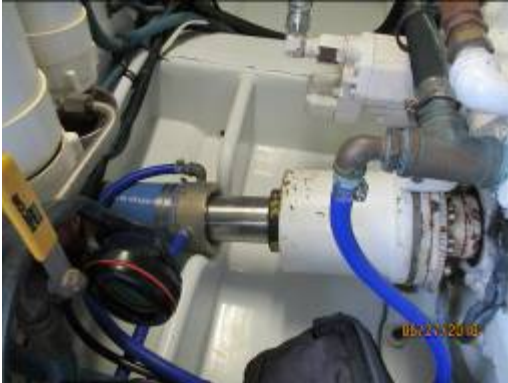
**port shaft seal**

Stuffing Boxes: Dripless types (manufacturer not observed)

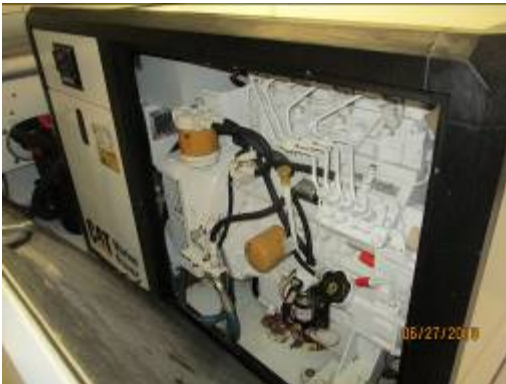
**port generator**

The vessel is equipped with (2) Caterpillar 3024C generators (port serial # SAG00256 arrangement 231-7687) (stbd serial # SAG00248 arrangement 231-7687). These are rated at 21 KW each. Both are fitted with Cat 220-1523 oil filters and Cat 067-6987 fuel filters. Exhausts were properly routed and double clamped. The port has 2027 hours of use and the stbd 1629. Both were operated during survey under a normal load. Proper voltage and frequency were observed.

IT IS RECOMMENDED THAT ALL FLUIDS AND FILTERS BE RENEWED.

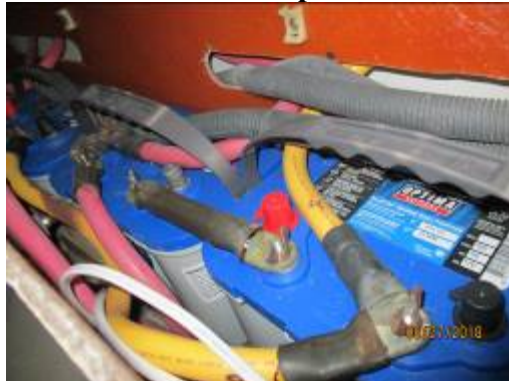
**port batteries**

Batteries: There were (4) banks of (2) Optima D34M 750 CCA each wired in series. These were secured in the machinery space in boxes designated solely for their use. Cables and terminals were found to be in good condition and covered. there was adequate ventilation.

\* C3 \* Bus bars at batteries were showing some corrosion.
